## Radio Repair Management PAE Transmitter Frequency 133.2 Mhz Sibiru-Biru

<sup>1,2</sup>Telecommunication and Air Navigation Engineering Study Program, Politeknik Penerbangan Medan

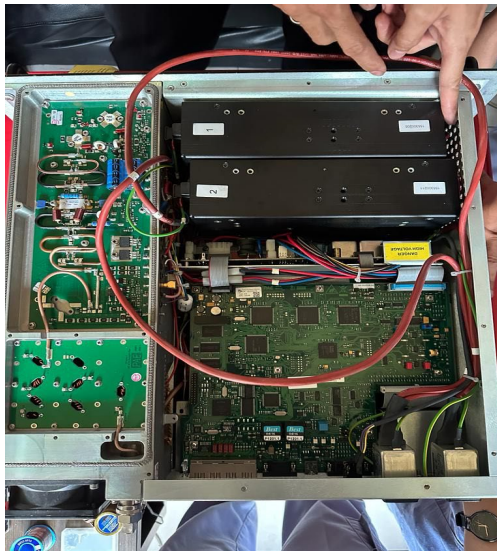
Figure 1. TX Radio Module Condition

- 1) Perform a physical radio check and the results are normal.

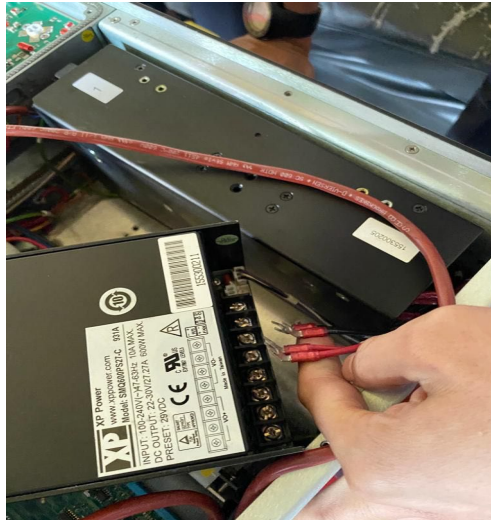
Figure 2. Checking the Power Supply

2) Check the power supply and the results are not normal.

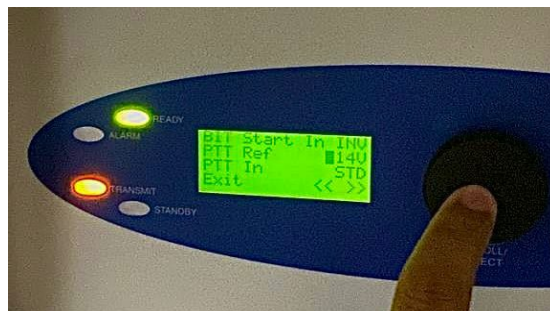
Figure 3. Voltage 14 Volt jumping condition

4) Checking the parameter menu and PTT test, it was found that the voltage was 14 volts and the results were still flashing.

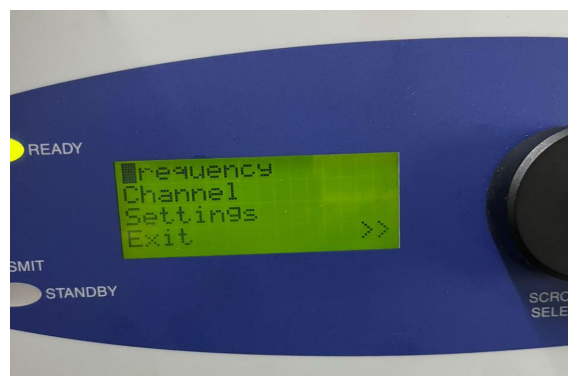
Figure 4. Settings menu display

a. Select *settings*, then click the *scroll button*

5) Perform voltage changes on the parameter menu.

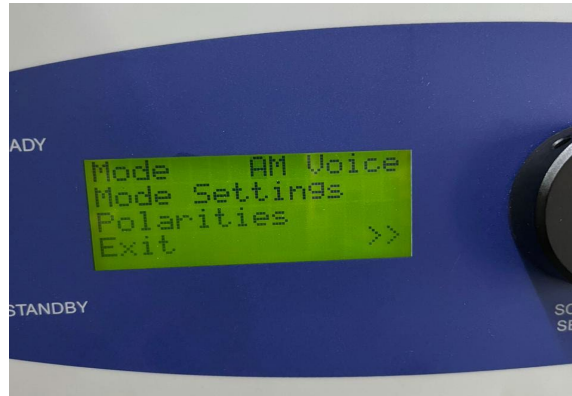
Figure 5. Polarities menu display

b. On the Polarities menu in the click, after selecting the polarities the technician opens the PAE module to find out what value clues will be set. On the PAE module page 23 there is a table 6 Polarity Settings which explains and gives instructions for PTT Ref to be set to +14 Volts, 0 Volts, or -14 Volts.

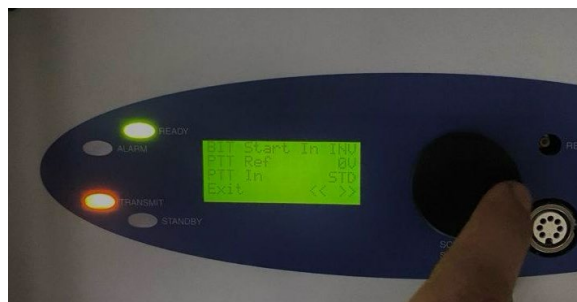
Figure 6. 0 volt voltage PTT Ref display

c. Because it is still a jumping condition, try again to change the voltage, select PTT Ref 0V, PTT in STD then activate PTT locally activate PTT remotely (external port) the result is local normal and the remote is abnormal.

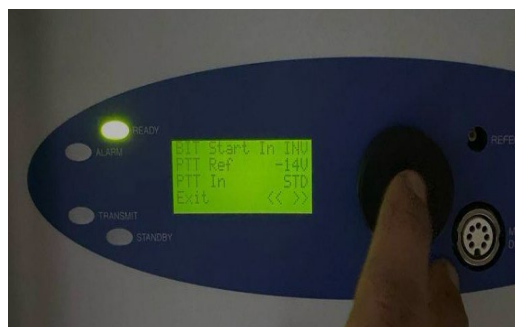
Figure 7. Display PTT Ref voltage -14 volts

d. For the next last try by changing the voltage of -14 volts, select PTT Ref -14V, PTT in STD activate PTT locally and then activate PTT remotely (external port) the result is local normal and remote normal.

After the VHF ER SiBiru-Biru Radio module was repaired and during the local test, the Tx radio condition had returned to normal, then the module was installed to siBiru-Biru. Radios can be reused to communicate

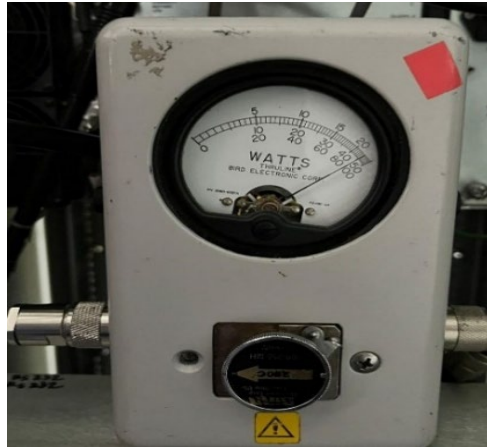
Figure 9. Forward power value measurement with element 250

7) Measuring the power output of Radio TX using a wattage meter and 250 elements, 10.Result: - forward power = 45 watts

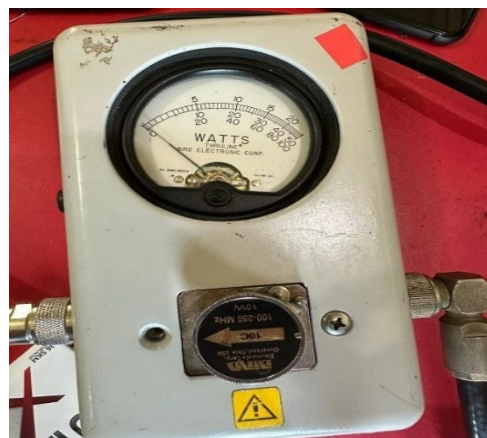
Figure 10. Measurement of reverse power value with element 10

- reverse power = 0.1 watts

Then the VSWR value is calculated: - VSWR Formula

$$VSWR = 1 + \sqrt{0.1/45} / 1 - \sqrt{0.1/45} \quad VSWR = 1 + \sqrt{0.0023} / 1 - \sqrt{0.0023} \quad VSWR = 1 + 0.0479 / 1 - 0.0479 \quad VSWR = 1.0479 / 0.954 \quad VSWR = 1.1$$

The result is a normal VSWR.
